Manhole Inspection Summary

Manhole # S47MM_007MH

Insp Date: **5/8/08 12:03 PM**

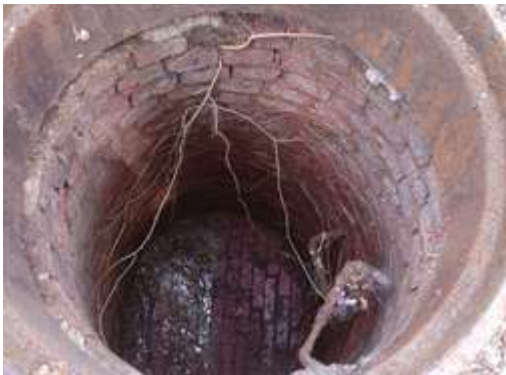
Defect 1

Condition: ☐ Sound ☐ Cracked ☒ **Root Intrusion** ☒ **Loose Brick** ☐ Deteriorated

Deterioration

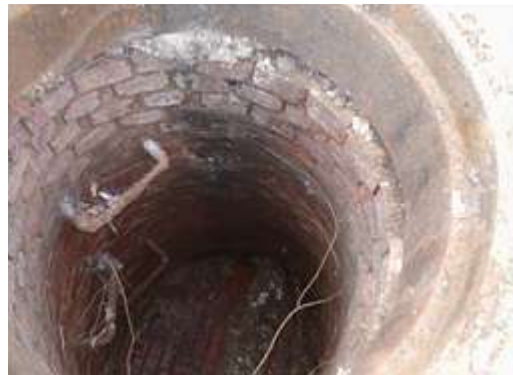
Defect 2

Loose bricks

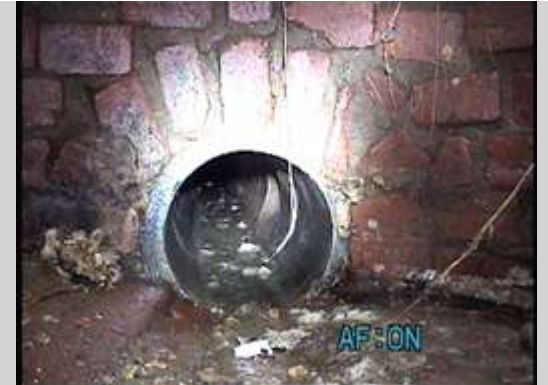
12 O'Clock Outflow

8 in. Circular Gravity Sewer
Pipe Out @ 12 O'Clock

Pipe Height: **8.4** (in.) Rod and Bar (Angled)
Pipe Material: **Clay** ☐ Pipe Lined
Invert Depth: **8.45** (ft.) Flow Characteristics: **Fast**
Deposits: ☒ None ☐ Mud ☐ Sludge ☐ Debris ☐ Grease
Silt Depth: (in.) Deposits Extent:
Infiltration: **None** Pipe Seal Cond: **Sound**

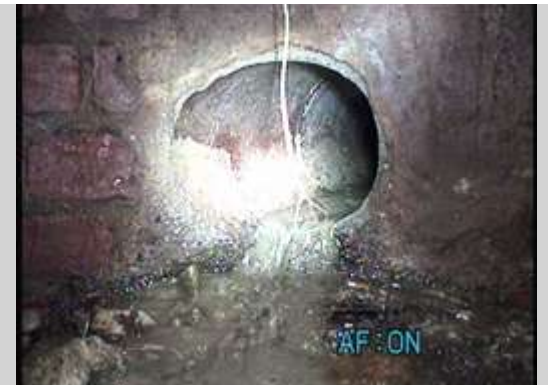
5 O'Clock Inflow

6 in. Circular Gravity Sewer
Pipe In @ 5 O'Clock

Pipe Height: **6** (in.) Rod and Bar (Angled)
Pipe Material: **Clay** ☐ Pipe Lined
Invert Depth: **7.75** (ft.) Flow Characteristics: **Fast**
Deposits: ☒ None ☐ Mud ☐ Sludge ☐ Debris ☐ Grease
Silt Depth: (in.) Deposits Extent:
Infiltration: **None** Pipe Seal Cond: **Sound**
